Safety

Message on Safety

■ Safety in Construction: GTL Project in Qatar

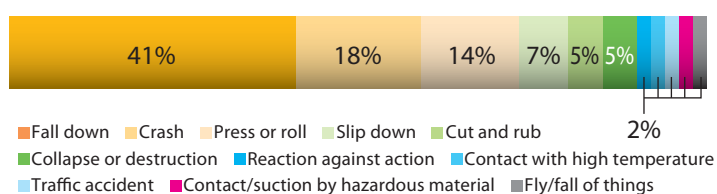
Injuries by category of incidents (2007 - 2010*)

When the number of injuries during 2007 - 2010 (figures for 2010 are up to the end of April, 4 fatalities and 40 injured with lost time incidents, total 44) are divided in accident categories, 41% of the injuries were due to fall down accidents. Therefore, the implementation of safety management and preventive measures for elevated work places is essential.

* Figures for 2010 are up to the end of April

When the incidents are analyzed on loss day basis, 74% of loss days was due to fall down and 24% of loss days due to press or roll, sum of which amounts to 98% of total loss days. Loss days due to fall down are more and have a large effect on total loss.

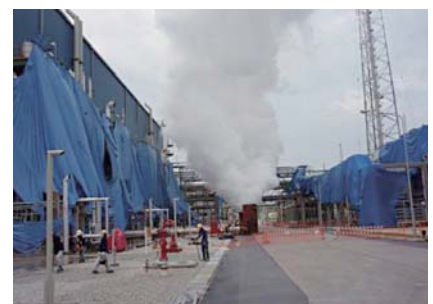
To clean the inside of piping with steam, the Silent Steam Blowing method* is employed to reduce noise for minimizing environmental impact.

* Silent Steam Blowing is a method to reduce steam blowing sound with a silencer installed.

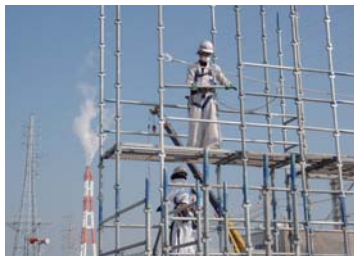
Training for wearing full-harness safety belt

Practical training is given to inexperienced workers for wearing full-harness safety belts all the time in dangerous working places.

* Full-harness safety belt is the safety belt to be worn around the body to soften shock like a parachute, different from conventional belt to be worn only around the waist.

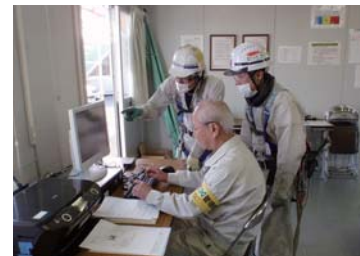
Entering data into the Hiyari-Hatto system

Hiyari-Hatto (near loss) experience data is utilized as live information to establish minute safety measures. For this purpose, a software for touch screen has been developed, and a personal computer furnished with the software is installed at the entrance of workers' saloon to enable them to enter reports easily at any time.

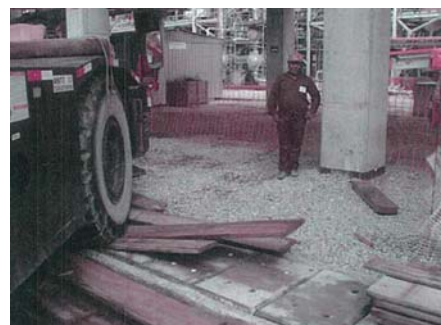
Crane passed over wooden boards

To allow a crane to move from a pipe rack area to a road, wooden boards were placed on the ground so as to disperse the load on the side ditch concrete cover. However, when a tire of the crane passed on the boards, one of the boards jumped up to hit directly the right leg of a worker who was 2.5 meter apart. The worker's leg bone was fractured.

- Although the procedure requires steel plates be used to disperse load, the workers placed thin wooden boards, neglecting the requirements because the step of side ditch was small.
- The worker was standing beside the moving heavy machine.
- KYK (Risk Prediction Activity) had not been done.

- (1) To be carried out at the construction site
 - At a general meeting, it was explained and reconfirmed that steel plates should be used to disperse the load of a passing heavy machine, and unevenness under the steel plates should be filled with sand.
 - Special safety education was given to Equipment operation supervisors and related workers.
 - A temporary fence with barricade was installed to prevent workers to come closer to a moving heavy machine.
- (2) To be carried out by the Head Office
 - The accident was immediately reported to all construction sites and group Companies to prevent similar accidents from occurring and to promote safety awareness.
 - Construction sites were instructed to strictly follow the procedure and to thoroughly implement "KYK."

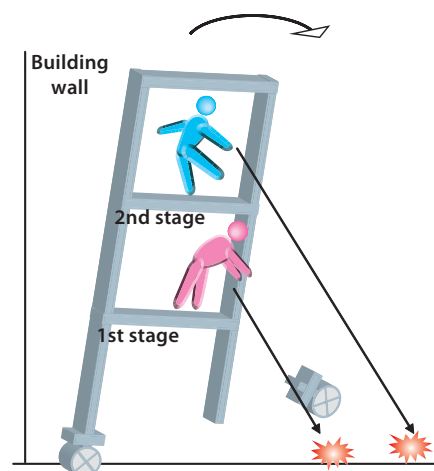
While two workers were dismantling a mobile scaffold (2 m wide, 5 m long, and 7 m high), the weld of one of the root of four wheels cracked and the entire scaffold turned over. As a result, two workers fell down from 3 m height of the first stage and from 5 m height of the second stage, respectively. Both the workers did not wear a safety belt. The worker who dropped from 3 m height (42 years of age) broke his right leg bone at one point while the other worker who dropped from 5 m height (38 years of age) broke his right leg bone at two points.

- Mechanical strength was insufficient because of the reduced wall thickness caused by corrosion.
- Pre-operation check tags specified by the procedure had not been attached. (After pre-operation check, green tags should have been attached to scaffolds permitted for use and red tags to scaffolds not permitted for use.)

- (1) To be carried out at the construction site
 - All scaffolds are checked and tags were attached in accordance with the procedure.
 - Prohibited use of red-tagged scaffolds and tag-less scaffolds was re-confirmed at Tool Box Meeting (TBM).
- (2) To be carried out by Head Office
 - The accident was reported to all the construction sites immediately to promote safety awareness.
 - Special safety audit of the accident site was conducted to give instructions about the accident point and general safety instructions.
 - The procedure was revised to limit the mobile scaffolding operating height and to add requirement for providing outriggers to prevent scaffolds from turning over. The revision was communicated to all the construction sites.
