Safety

Safety Record

Lessons Learned from Accidents

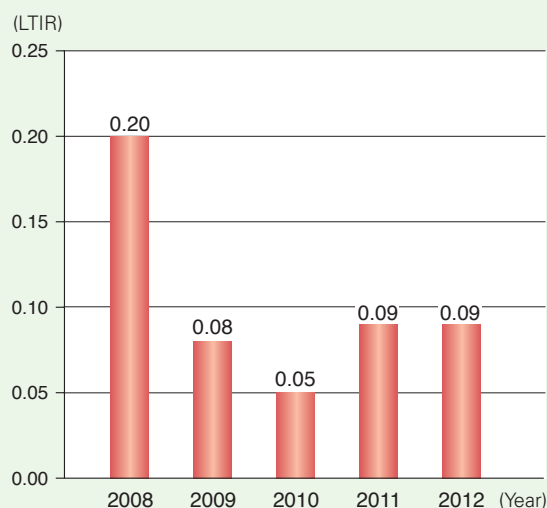
Total Recordable Incident Rate (TRIR) shows continuous downward trend, and it indicates decreasing of number of incidents. TOYO group aims for zero accident as a safety management objective. Hence our target is to further reduce Lost Time Incident Rate (LTIR) and Total Recordable Incident Rate (TRIR).

*1: Lost Time Incident Rate (LTIR) = (B) × 1,000,000 / (A)

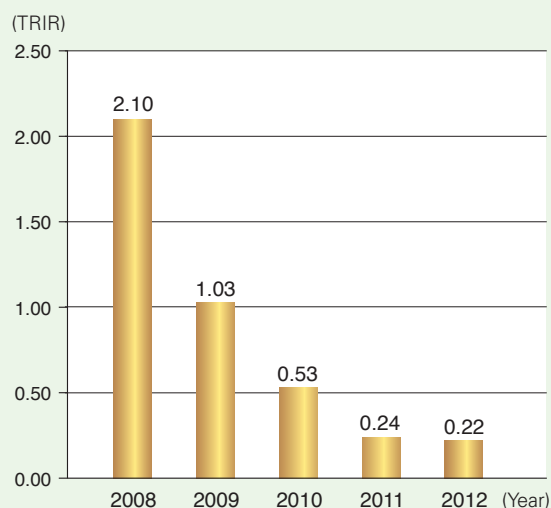
*2: Total Recordable Incident Rate (TRIR) = (C) × 1,000,000 / (A)

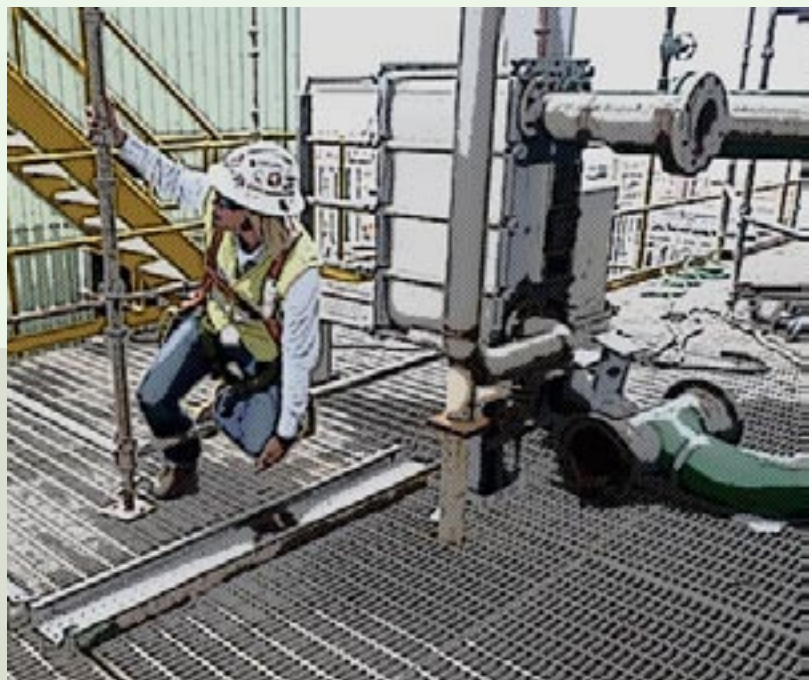
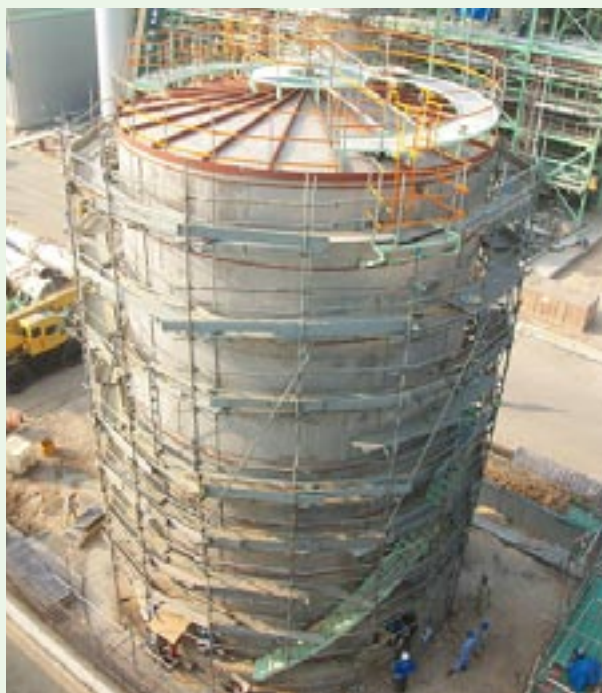
■ Stumbling/Tumbling

On fourth-floor landing of a steel tower for Reactor, a worker tried to pass across the lower scaffolding leg which was meant for paint repair and stumbled. His left knee got smashed against the steel board which was kept temporarily, as he tumbled. On hospitalization and subsequent X-ray test, it was revealed that he had suffered fracture on left knee.

- Improper placement on access way
- Lack of awareness toward the safety access
- Lack of housekeeping
- Lack of warning-sign board

- Checked and rectified unsafe conditions especially for the scaffolding
- Marked clear access
- Proper housekeeping initiated
- Installed a warning sign board

- To prevent similar accident, the incident report was issued immediately and head office alerted this incident to all construction sites.
- Issued instruction to comply strictly with procedures, implementation of KYK (Hazard Prediction Activity) to site

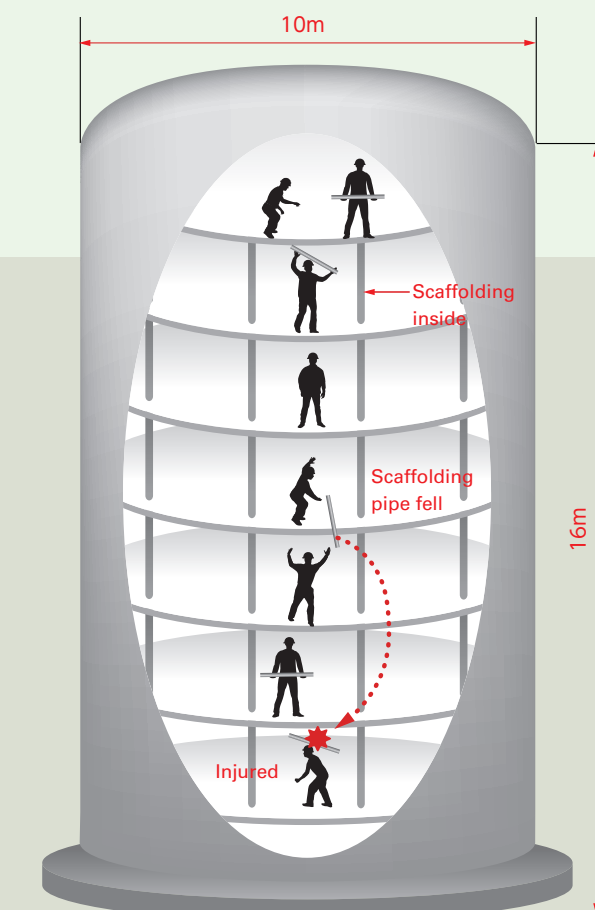
■ Accident Due to Flying, Falling of Objects

During dismantling of scaffolding inside flat bottom tank (diameter: 10m, height: 16m), passing the dismantled scaffolding pipe from worker on 7th floor to that on 4th floor, the worker did not catch the pipe due to which the scaffolding pipe (diameter: 50mm, length: 1m, weight: 5kg) fell for about 5m below and hit head of a worker's standing on 1st floor. The worker suffered head injury.

- Workers did not comply the set procedure of taking dismantled pipe with rope.
- No Tool Box Meeting
- No Work Permit
- Foreman instructed the commencement of the work without noticing the change of work contents.

- Complied with procedures and imparted safety aspects
- Reliable implementation of TBM
- Re-orientation of the foreman
- Started Conducting meeting during change of work for proper understanding of next work

- For prevention of similar accident, the incident report was issued immediately and head office alerted this incident to all sites.
- Instruction for compliance with procedures at site
- Prepared instruction for conducting meeting at the time of change of work
